Restoring the Beaches of Puget Sound – Two Promising Prototypes in Everett, WA

Jon Houghton¹, David Simpson², Jim Starkes¹, Derek Ormerod¹, Jason Stutes¹

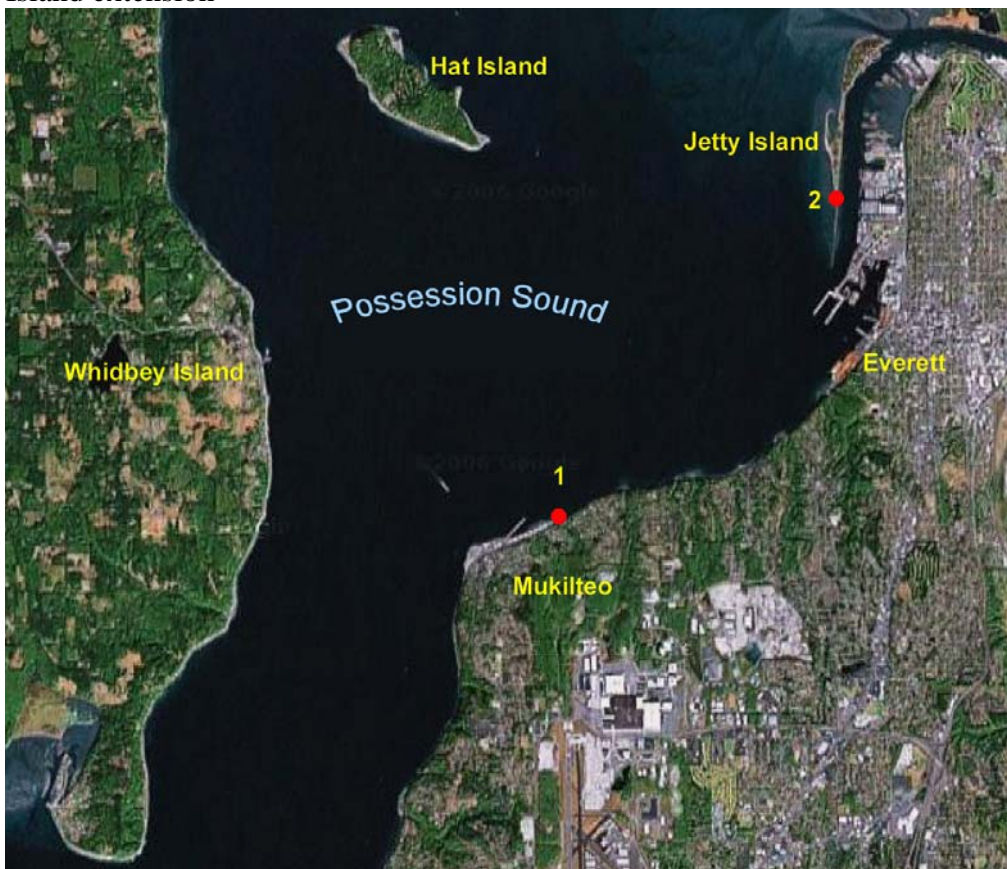
Figure 1: Vicinity map, site 1 is the rail/barge transfer facility and site 2 is the Jetty Island extension

This paper describes two recent projects constructed near Everett, Washington (Figure 1) where the objective was to rebuild the beach in front of armored beach segments to provide the full extent of foreshore, storm berm, and backshore that would be expected to

Background. The Port of Everett (Port) has constructed a new rail/barge transfer facility along the westernmost shoreline of the City of Everett (Figure 1). The primary use of the facility will be to transport aerospace components to various industries at Paine Field. To support existing and new aerospace programs, the facility must provide the flexibility to transport larger cargo containers from the Port to Paine Field with minimal disruption of rail traffic on the Burlington Northern/Santa Fe Railroad (BNSF) mainline. A major restoration opportunity was identified during project permitting and design. Specifically, restoration of approximately 1,100 feet of shoreline beginning at the east end of an existing tank farm fill and extending under the new pier to the east along the BNSF tracks (Photos 1, 2). Net alongshore sediment transport is to the east (Schwartz et al. 1991).

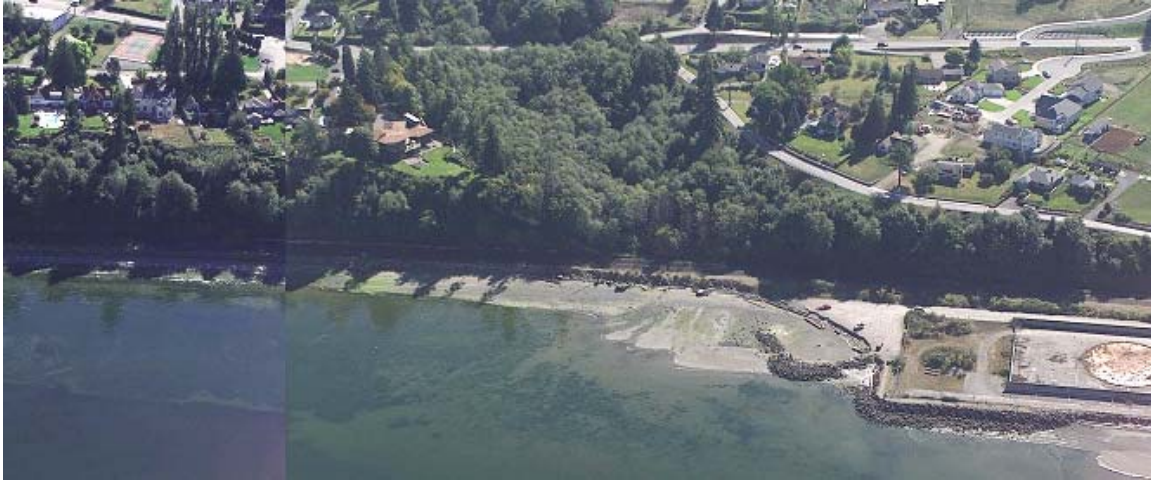
Photo 1: Pre-construction aerial photo detailing hardened shoreline, derelict tank farm, and BNSF main line.

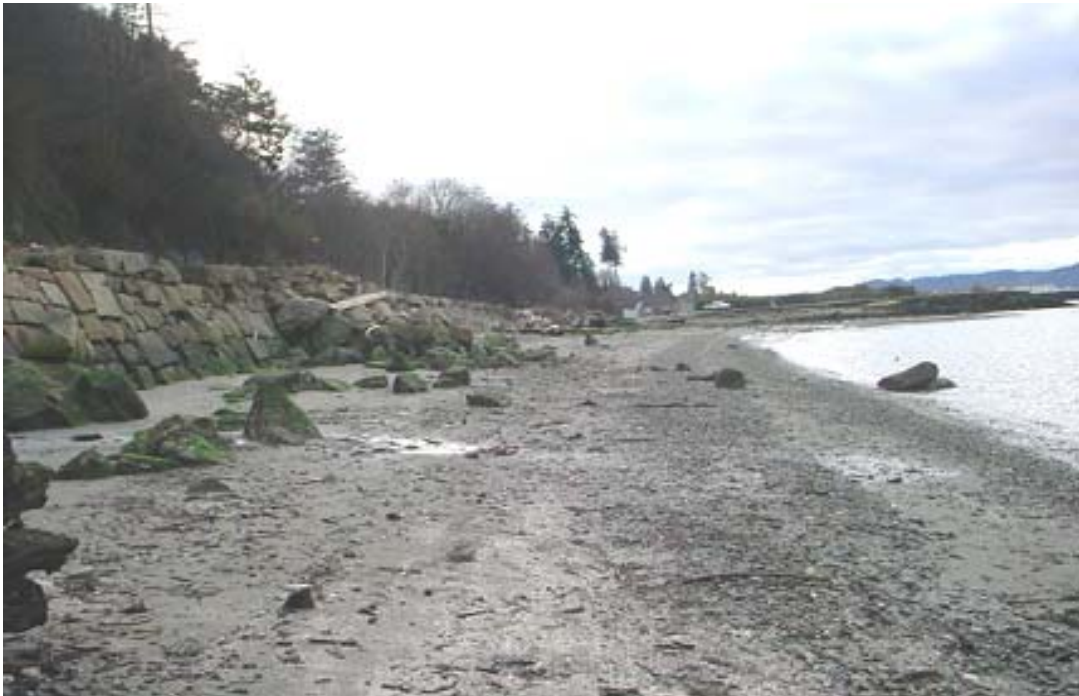
Photo 2: Pre-construction photo on eastern side of proposed enhancement looking west toward derelict tank farm.

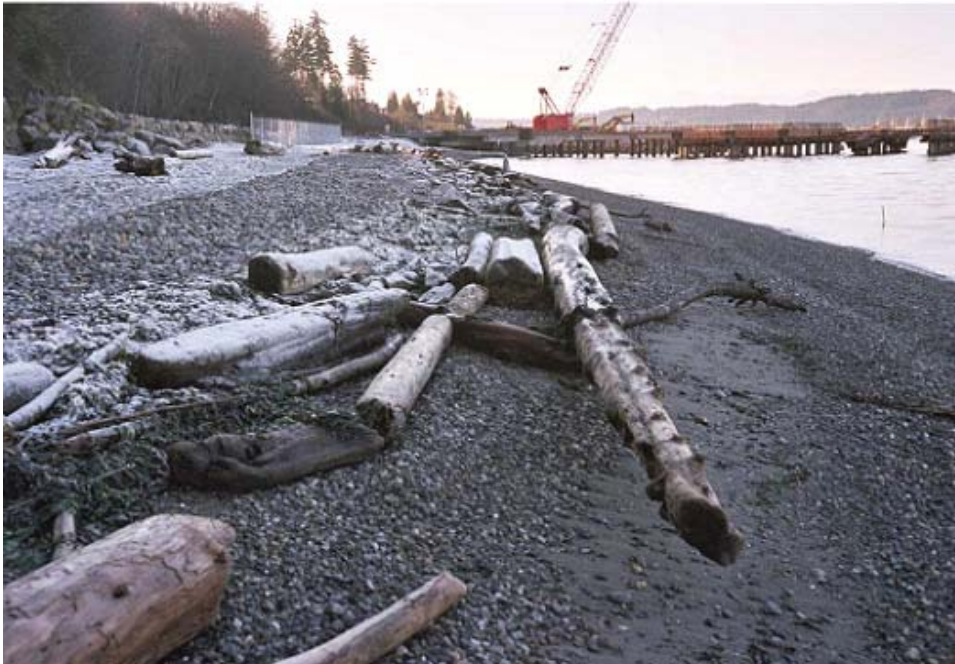
Photo 3: Completed beach east of pier, December 2005

Construction. The project design included a coarse beach core with a mixed sediment beach face and a sandy backshore (Figure 2). It was expected that waves would sort the mixed sediment placed on the beach face to provide bands of predominantly sand sediment and shell that are preferred spawning habitat for forage fish. Construction of the beach restoration began in September 2005 with placement of approximately 7,100 metric tons of the beach core material, 7.6-cm minus rounded river gravel. The beach face material, approximately 6,600 metric tons of habitat mix of 3.8-cm minus sand, granules, and pebbles, was placed and graded to a 7h:1v slope; east of the pier this work was completed in December 2005 (Photo 3); west of the pier, the beach was completed in

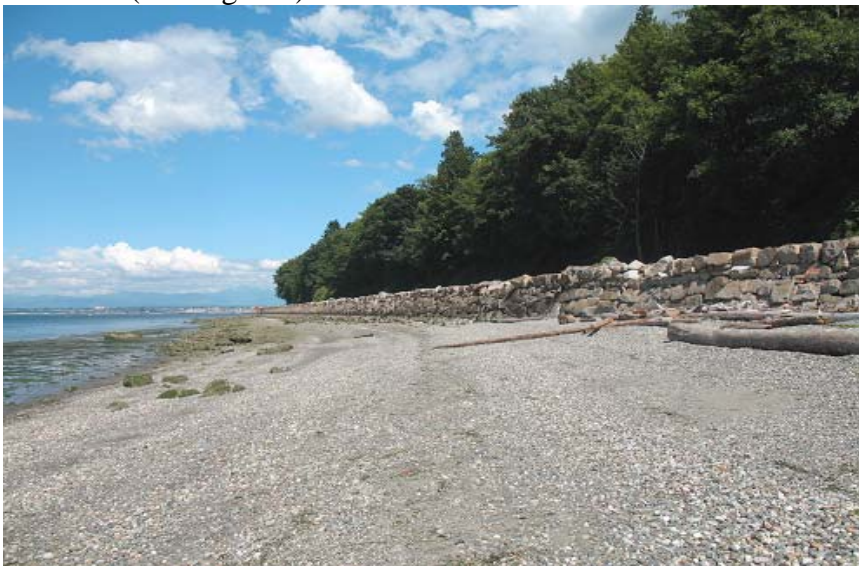
Photo 4: Transition zone between restored and unrestored beach in front of railroad bulkhead (looking east)

Physical monitoring of beach stability and sediment movement (May and November 2006) showed that the larger central portion (approximately 300 m) of the restored area showed only minor redistribution of sediments and a few cm of accretion. A substantial storm berm had formed and a large number of large woody debris pieces had accumulated (Photo 3). The western end (approximately 25 m) of the reconstructed beach had lost some finer material from the surficial habitat mix. This material may have been deposited in the backshore immediately to the east and/or transported to the accreting beach face farther to the east. The east end of the restored beach, which was unconfined by terrain features, was expected to lose material to the east. As of November 2006, the beach profile located 10 m from the end of the construction had lost approximately 1.0 m from the beach face. This material had been moved eastward by waves forming a gradual and natural-appearing transition with the unrestored beach in front of the railroad bulkhead to the east (Photo 4).

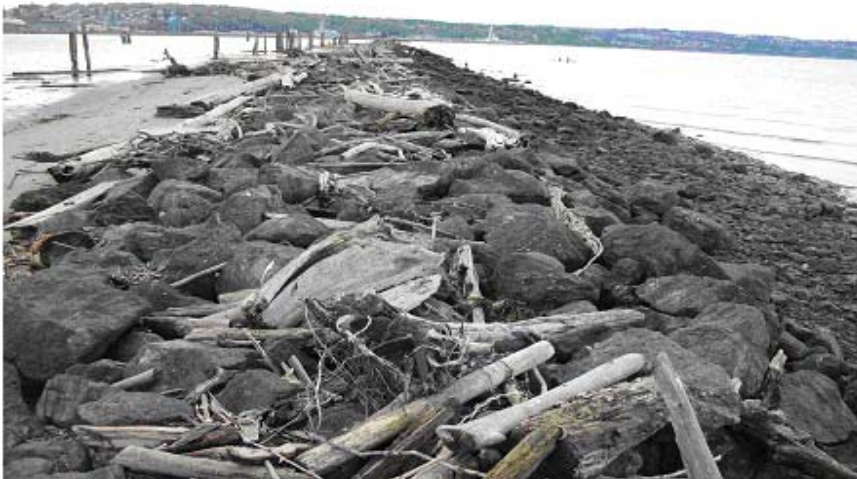
Photo 5: Rock jetty looking south – pre-project (November 2006).

The Corps of Engineers is responsible for maintenance dredging of the lower Snohomish River navigation channel and the Port of Everett is responsible for sediment disposal. Since 1990 there has been a strong emphasis on beneficial use of dredged materials for habitat enhancement (e.g., Houghton and Gilmore 1995) and capping of contaminated bottom areas. Jetty Island (Figure 1, Site 2) was created by hydraulic placement of dredged materials on the west side of a 3-km long rock jetty built about 1905 to protect the channel and Everett harbor. Excellent marine and upland habitats (a sandy beach, log-strewn backshore, and thriving dune and scrub-shrub uplands) have been created and periodically enhanced along the northern three quarters of the island but the southern quarter of the rock jetty crosses the lower intertidal zone as a steep rocky shoreline (Photo 5, right side).

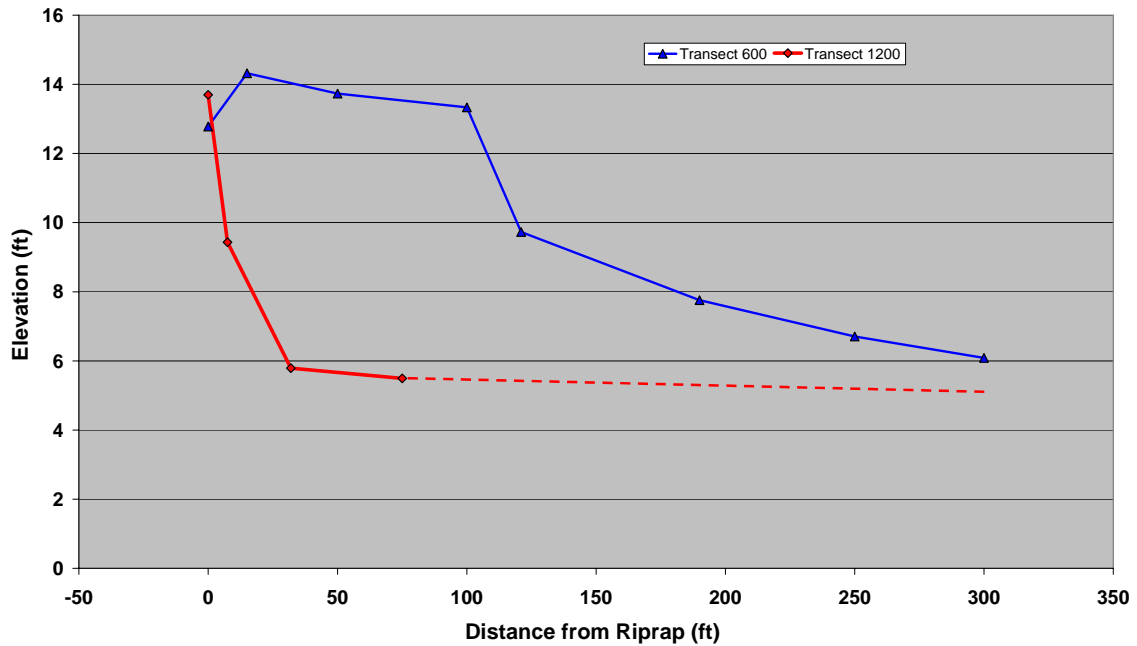
Figure 3: Jetty Island cross-section pre-/post beach nourishment (rock jetty on the left)

We designed a project that was included in the Snohomish River Basin Salmon Conservation Plan (SBSRF 2005) to place a large volume of clean sand along the rock jetty extending south from the island uplands to improve the nearshore migration corridor for juvenile salmonids. In February 2007, the Corps of Engineers dredged the lower channel and hydraulically placed approximately 45,000 m³ of sand along the west side of the jetty essentially extending the island shoreline by approximately 1,000 feet (Figure 3, Photo 6). The new island section has a backshore of approximately 75 feet in width that is expected to be colonized by native vegetation and a natural sloping beach face. We have designed a long-term monitoring program for the site that will be carried out with the aid of the People for Puget Sound Stewardship program. The foreshore will be shaped by wave action and is expected to develop a storm berm that will accumulate a substantial quantity of large woody debris; late winter floods in 2007 had already deposited over 2 dozen pieces of large wood on the beach by March 2007.

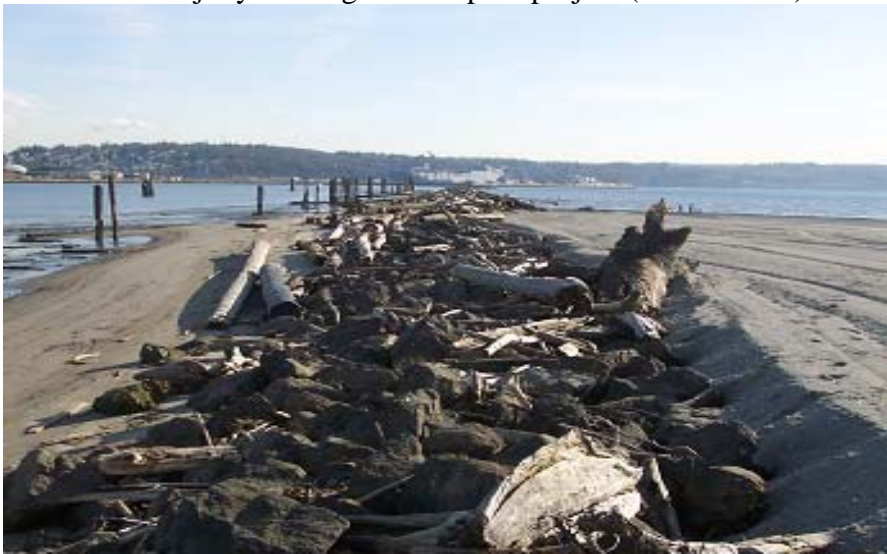
Photo 6: Rock jetty looking south – post-project (March 2007)
